### Mapiu-Mapara - Water Quality Summary 2023

## Mapiu-Mapara 2023 (22 samples, 6 sites)

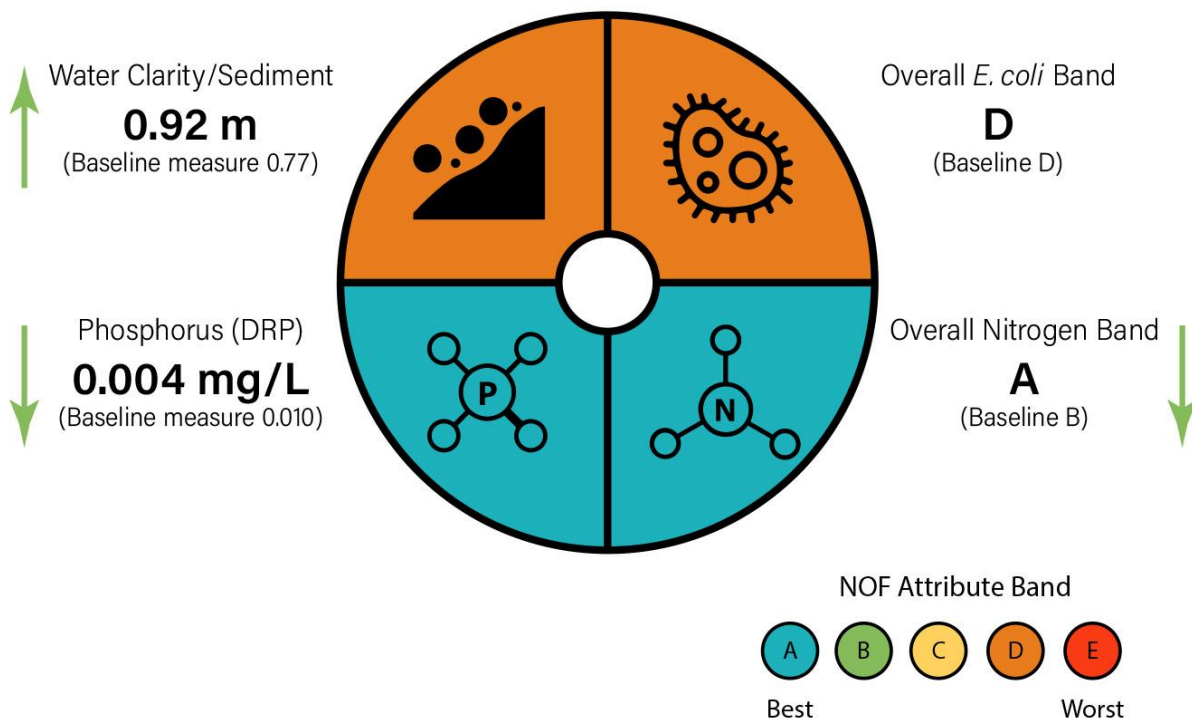
Water samples were collected from 6 stream sites across the Mapiu-Mapara catchment. Monitoring sites were located on Mapara stream, Mangaiti stream, Mapiu stream, Waewaepitau stream and Puputaha stream. The below water quality dial summarises 22 individual samples collected across 6 sites, between January 2023 and December 2023.

Water clarity was poor, indicated elevated levels of suspended sediment, which impacts aquatic life. *E. coli* was elevated which poses a risk to human health when swimming or through contacting water. Nitrogen and dissolved reactive phosphorus (DRP) were very low, which supports river health. Water clarity and *E. coli* did not meet national water quality standards, while nitrogen and dissolved reactive phosphorus did meet national standards.

Arrows indicate an increase or decrease in values compared to the baseline. The baseline was calculated from 5 years of data collected by Waikato Regional Council at 5 sites, between 2015 and 2019. An increase in water clarity is positive for river health, while an increase in all other attributes may impair river health.
